AECD-3795

STUDIES OF THE ALUMINUM-URANIUM
ALLOYING REACTION

By
D. W. Bareis

Brookhaven National Laboratory
Upton, New York

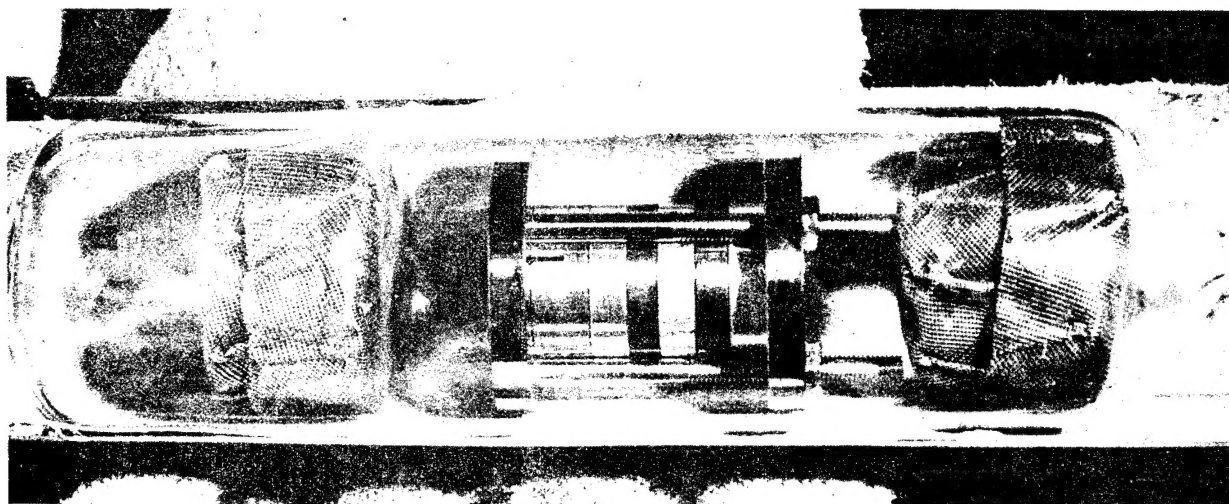
Figure 1. A sandwich assembly (#3).

Figure 1 shows a typical sandwich assembly under test conditions. Figure 2 shows an exploded view of the various components used in the assemblies. Not all of these components were used in every assembly. The components are listed and described in Table I.

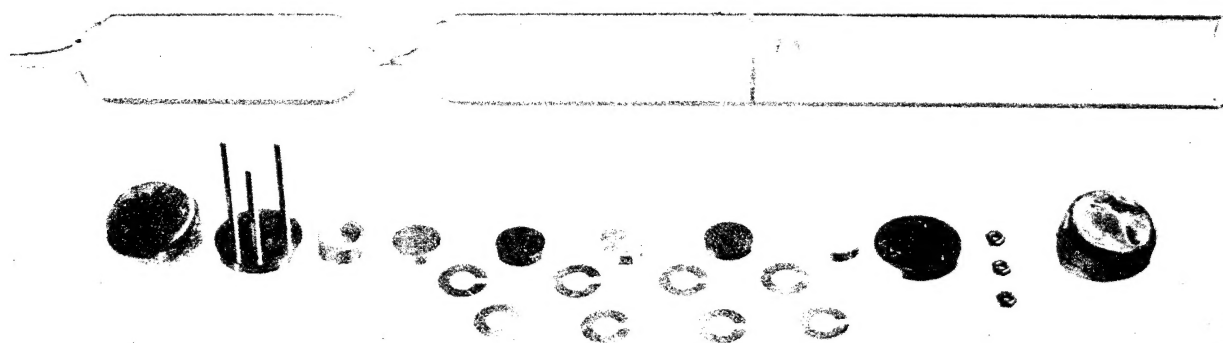
Figure 2. The assembly components.

The uranium and aluminum surfaces were machined parallel and smooth to a tolerance of ± 0.1 mil. The disks were then polished metallographically and stored in absolute alcohol. The various components were cleaned and stored in alcohol. The components were dried and clamped together under a purified helium atmosphere. Then they were placed within the pyrex tube, and the tube was sealed at the point marked "A" in Figure 2, under a helium atmosphere. The pyrex container was evacuated for 15 hours, and then sealed at the point marked "B" in Figure 2.

The various components of the assembly (Figure 2 and Table I) were thoroughly cleaned in order to remove any substances which might later volatilize and contaminate the aluminum and uranium surfaces. Only reagent grade solvents and absolute alcohol were used. The steps in the cleaning procedure for the assembly components are outlined below.

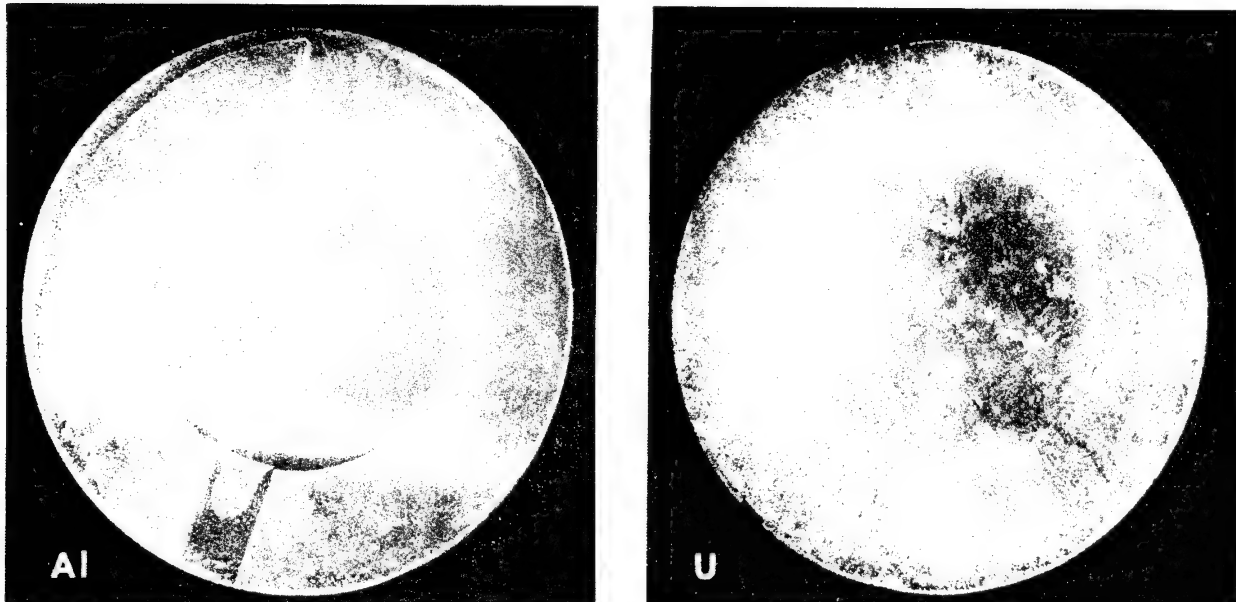
Figure 3. Al and U surfaces after the test. No reaction - surfaces separated (Interface #10, Assembly #1).

The reaction can be portrayed very effectively by means of photographs of the metal surfaces. Figures 3 through 6 show the various stages of the reaction.

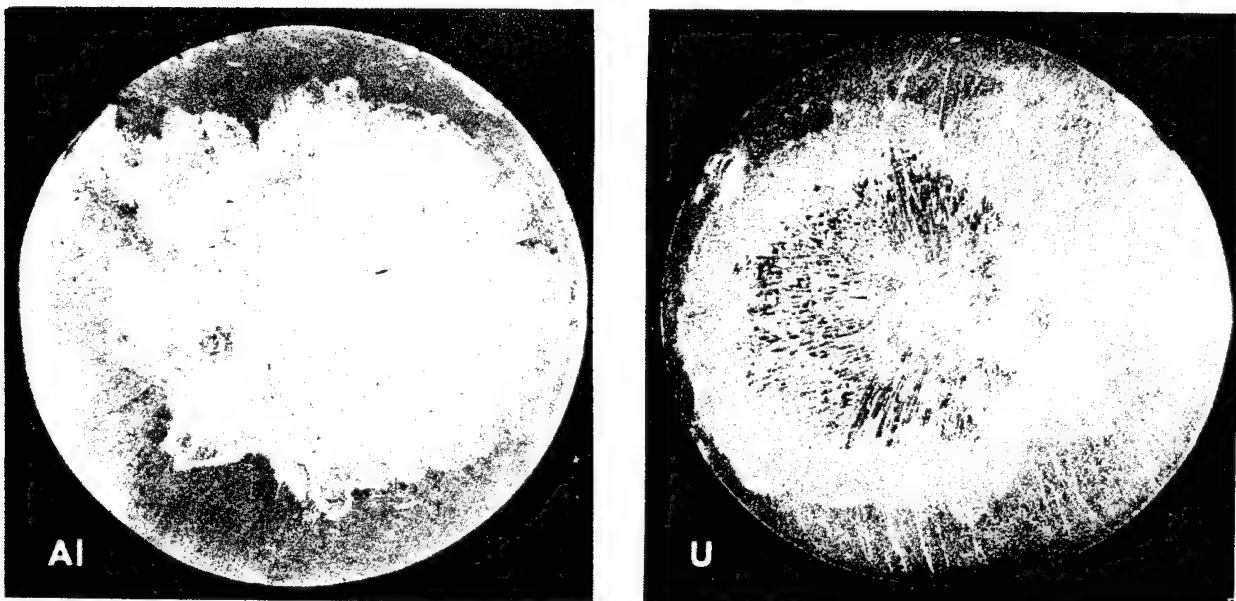
Figure 4. Al and U surfaces after the test. Grain structure visible within contact area (Interface #2, Assembly #4).

The preliminary stage (Figure 4) left the disks held very tightly together. The grain structure was usually apparent when the disks were parted. The surface of the aluminum was depressed over the area of the reaction, while the uranium surface was raised correspondingly; this could only be determined by the use of a microscope, since the surfaces actually felt and looked smooth.

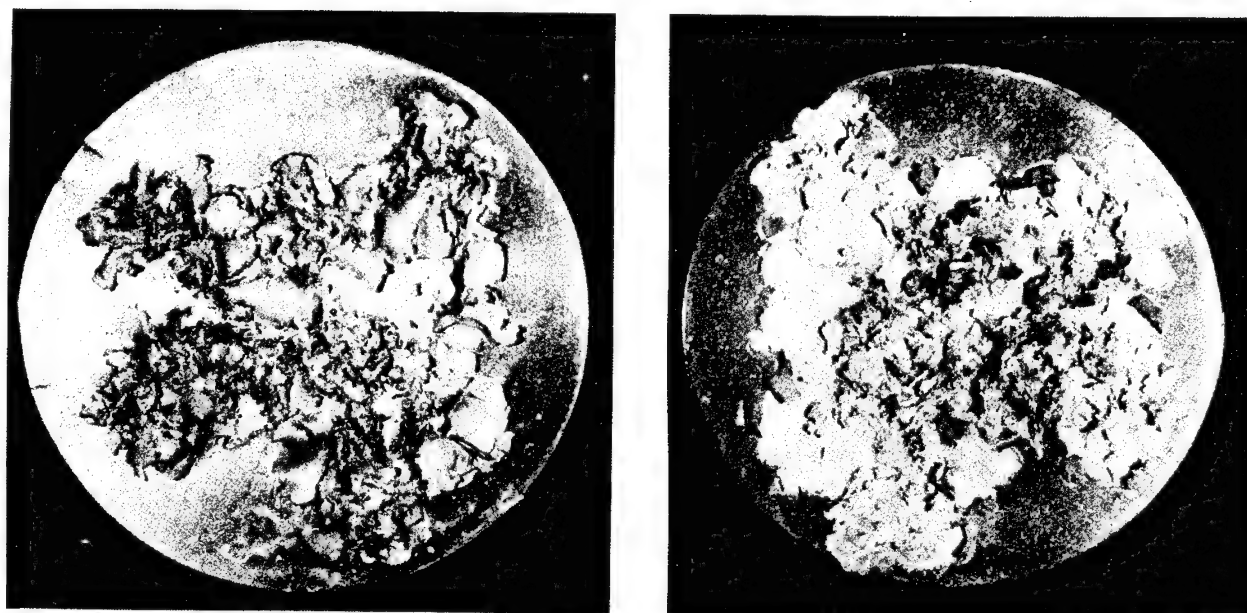
Figure 6. Al and U surfaces after the test. "Blister" formation over contact area (Interface #2, Assembly #1).

The advanced stage (Figure 6) of alloy formation, or "blistering," forced the aluminum and uranium surfaces apart as much as 1/16 inch. The aluminum compression cup and the aluminum disks were visibly deformed. It was very apparent that the alloy was much less ductile than the aluminum. The uranium and the aluminum disks were separated easily, with the alloy again breaking off near the uranium surface. The alloy cones, or "blisters," which were formed were very thin, consisting mostly of void space. The alloy expansion was almost entirely into the aluminum, there being only a slight depression in the uranium surface below the "blisters." The calculated increase in volume due to the UAl_3 alloy formation, without the void space, was only 17%. This increase in volume of the alloy could only be attained by movement into the softer aluminum surface. If one assumes that the alloy forms a cone, the base angle would have to be approximately 20° , which indicates that the blister formation could have been caused by the volume expansion of the alloy formed in the reaction.

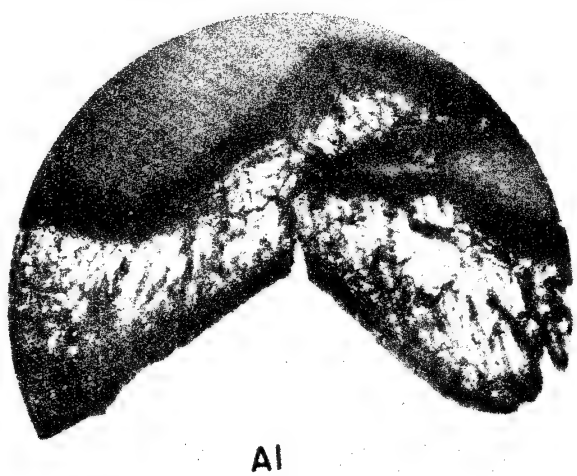
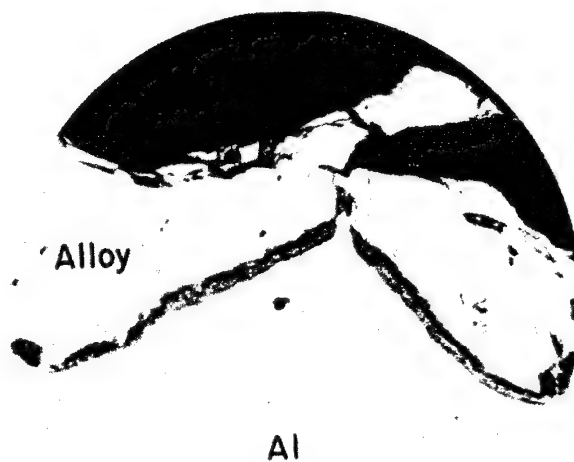
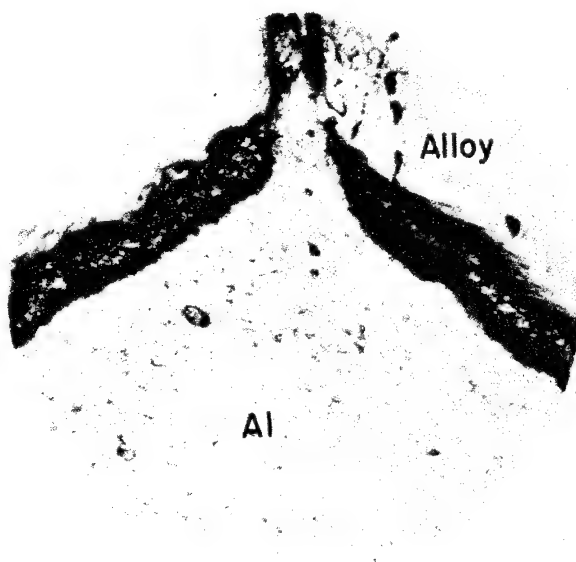
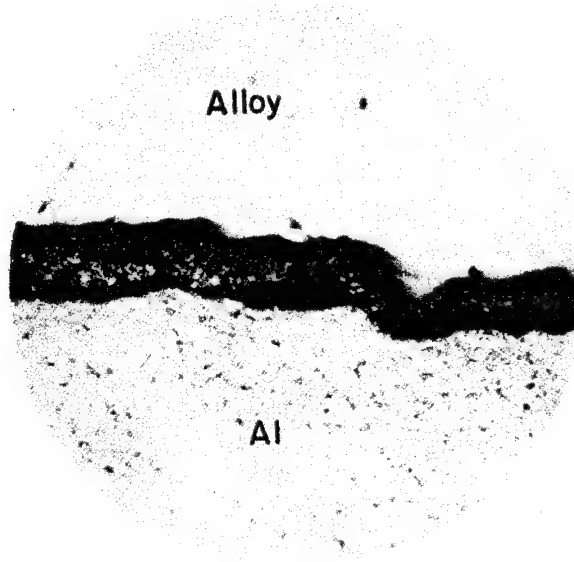
(a) Alloy on aluminum surface
(150X, HF etch).

(b) Alloy on aluminum surface
(150X, no etch).

(c) Black substance between alloy and alu-
minum (500X, no etch).

(d) Black substance between alloy and alu-
minum (500X, no etch).

Figure 8. Enlarged cross section of an aluminum disk (Assembly #1).

7. The role which the black substance found between the aluminum and the alloy plays in the alloying reaction should be investigated.

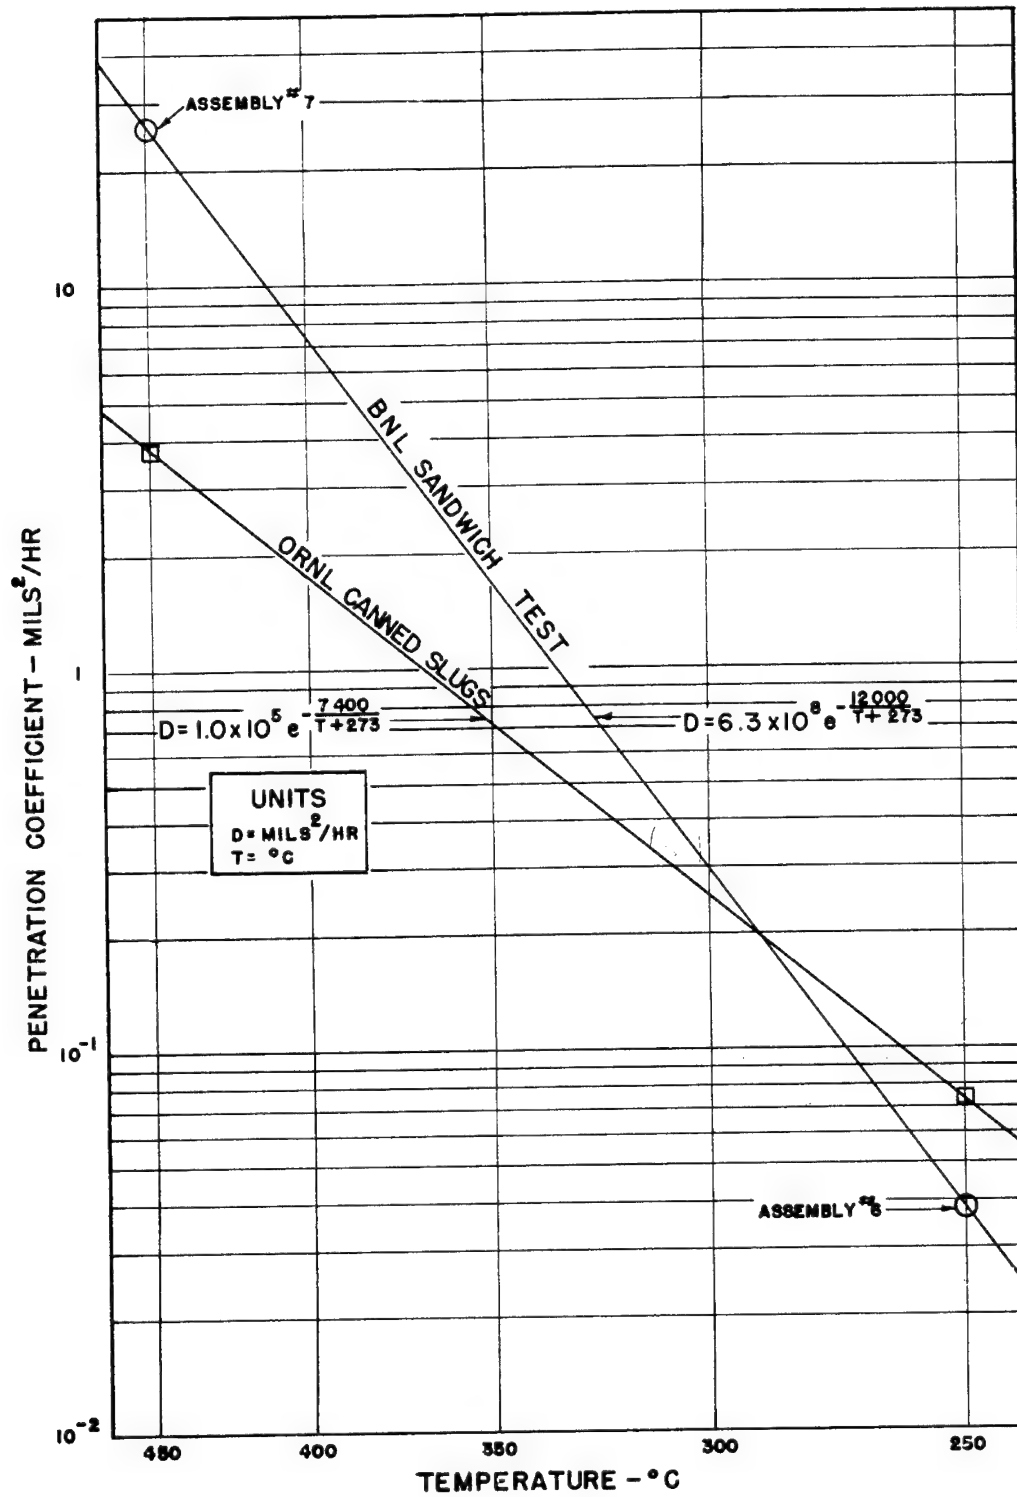
Figure 9. Variation of the maximum aluminum penetration rate with the temperature using BNL and ORNL data.

It is possible to rearrange the equations shown in Figure 9 in the form of the diffusion equation:

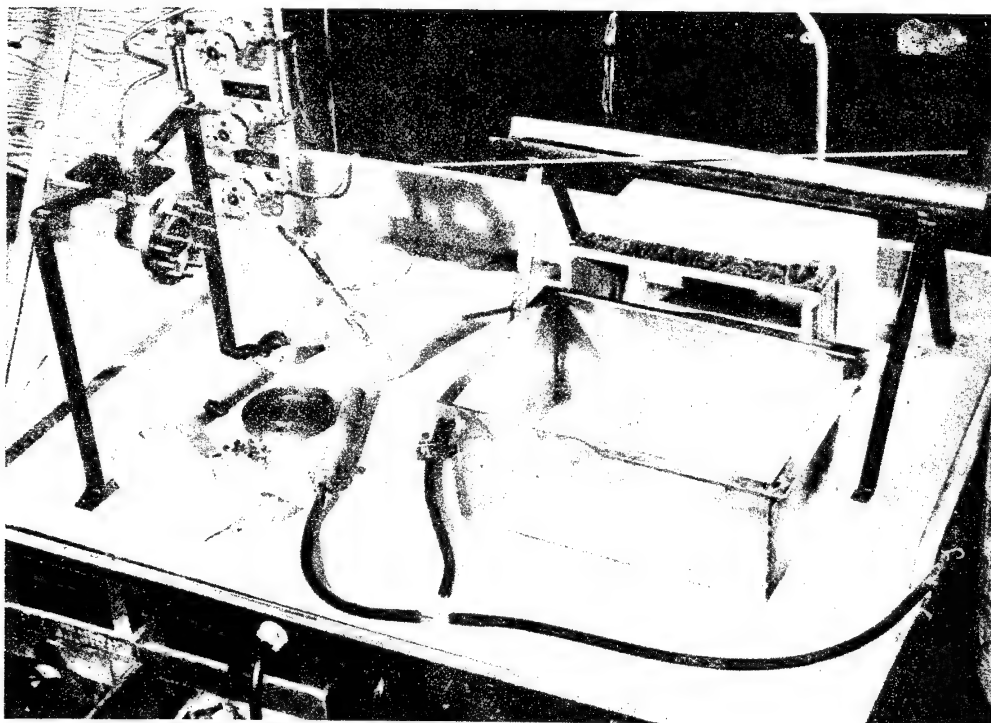
Figure 10. Equipment used to assemble the sandwich.

Most of the equipment used to assemble the aluminum and uranium sandwich is shown in Figure 10. The support on the left holds a vacuum chamber which was

used to remove the last traces of alcohol from the assembly. The stainless steel tank on the right was used to assemble the disks in the clamp and place the sandwich in the vacuum chamber beneath the surface of the alcohol medium.

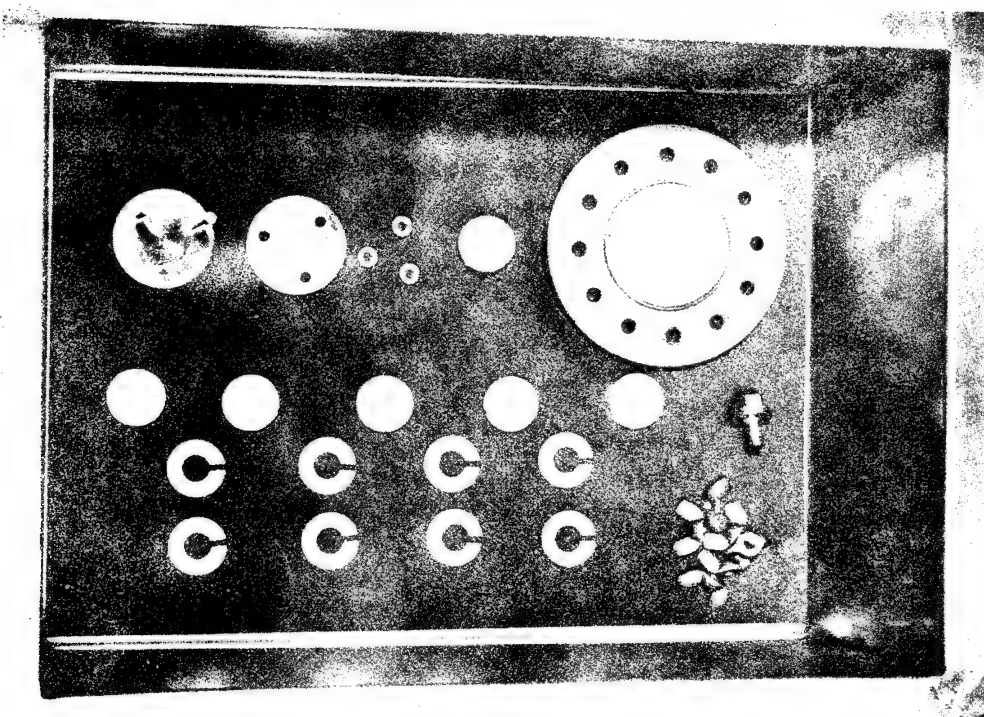
Figure 11. Assembly components in the stainless steel tank.

Prior to the assembling operation, the disks were polished on the "Gamel" cloth with #2 alumina and water. Then they were rinsed with alcohol on the polishing wheel and placed in the stainless steel tank filled with absolute alcohol (Figure 11).

Prior to the assembling operation, the disks were polished on the "Billiard" cloth with the carborundum abrasive and water; then they were rinsed with alcohol on the polishing wheel and placed in the stainless steel tank containing absolute alcohol (Figure 11).

After cleaning, the assembly components and the brass cover plate from the vacuum chamber were placed in the stainless steel tank containing alcohol by means of forceps (Figure 11). Rubber gloves previously cleaned and rinsed in alcohol were used to assemble the components in the tank. The disks were placed loosely in the clamp, allowing a slight space between surfaces, and the tank was raised under the vacuum chamber until the chamber was completely immersed in alcohol (Figure 12). Helium was then allowed to flow freely through the vacuum chamber. The assembly was inserted in the vacuum chamber, and the cover plate set loosely in place. The pan was then lowered while the helium flowed rapidly past the cover plate. When the alcohol stopped dripping from the chamber, the cover was bolted on and the helium turned off. The cylinder was then alternately evacuated and flushed with helium. This allowed the alcohol in the cylinder to evaporate away, leaving the assembly perfectly dry. The helium also diluted and flushed away any possible contamination from air leaks into the cylinder. This procedure was followed for approximately 1/2 hour. At this time, it was assumed that the alcohol had evaporated completely from the assembly. The helium was left on and the cover plate removed. The only opening was the clearance between the assembly clamp and the chamber wall, which was quite small (Figure 13). The positive helium pressure prevented air from entering the chamber and causing contamination of the assembly. The three nuts on the stainless steel clamp were tightened evenly by the use of a torque wrench. A torque of 20 inch-pounds was used in all cases. During the assembling operation, the glass container was cleaned and rinsed in acetone and allowed to dry on the sealing apparatus by circulating helium through it. A nickel screen basket containing uranium turnings was inserted into the tube and also allowed to dry. The pyrex container was placed in position in front of the vacuum cylinder. The helium flow remained on in both directions (from both the vacuum chamber and the pyrex container). The brass plug on the left end of the vacuum cylinder was removed and the assembly inserted into the tube with the aid of a clean rod (Figure 14). The second uranium-filled nickel basket was placed in the tube and allowed to dry. A one-hole rubber stopper covered with aluminum foil was placed in the end of the pyrex tube. The helium flowed through the tube for approximately 1/2 hour. At this time the pyrex tube was sealed at point "A," keeping a helium atmosphere in the container at all times (Figure 15). The completed assembly was then evacuated for approximately 15 hours. After this period of time, the vacuum usually ranged from 1 to 5 microns. The capillary section, point "B," in the pyrex tube was then sealed off, leaving the completed assembly.

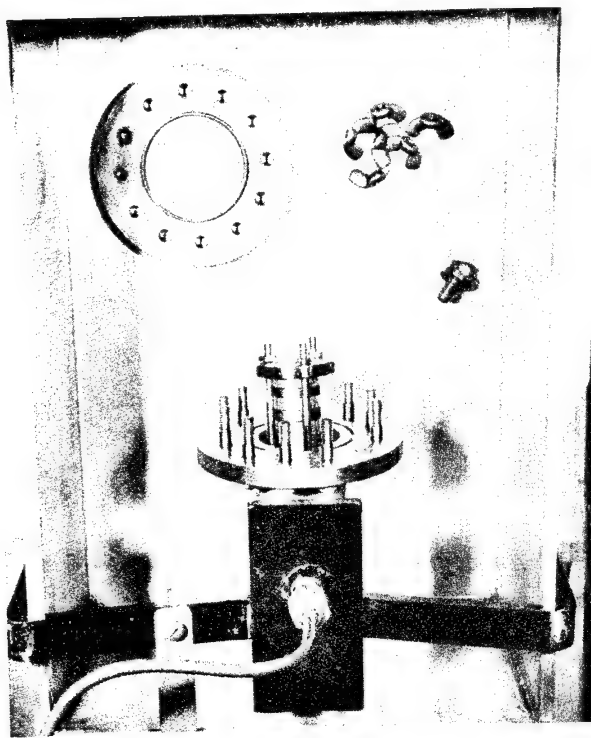
Figure 12. Assembly entering the vacuum chamber.

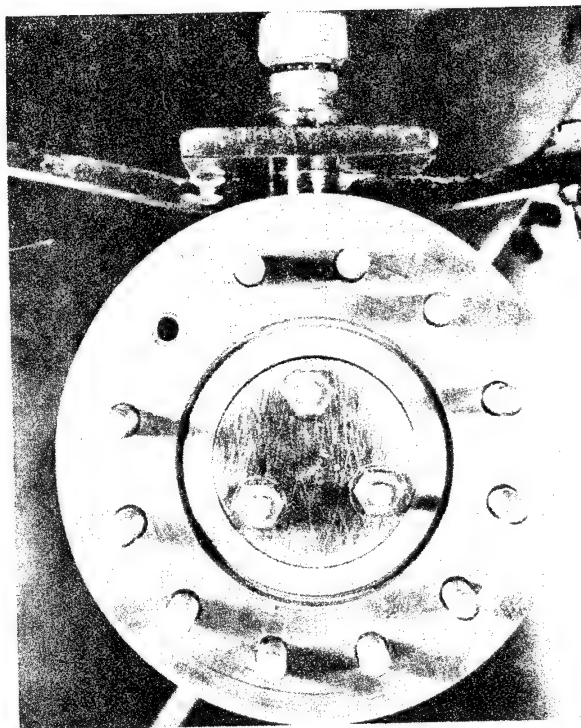
Figure 13. Assembly in the vacuum chamber.

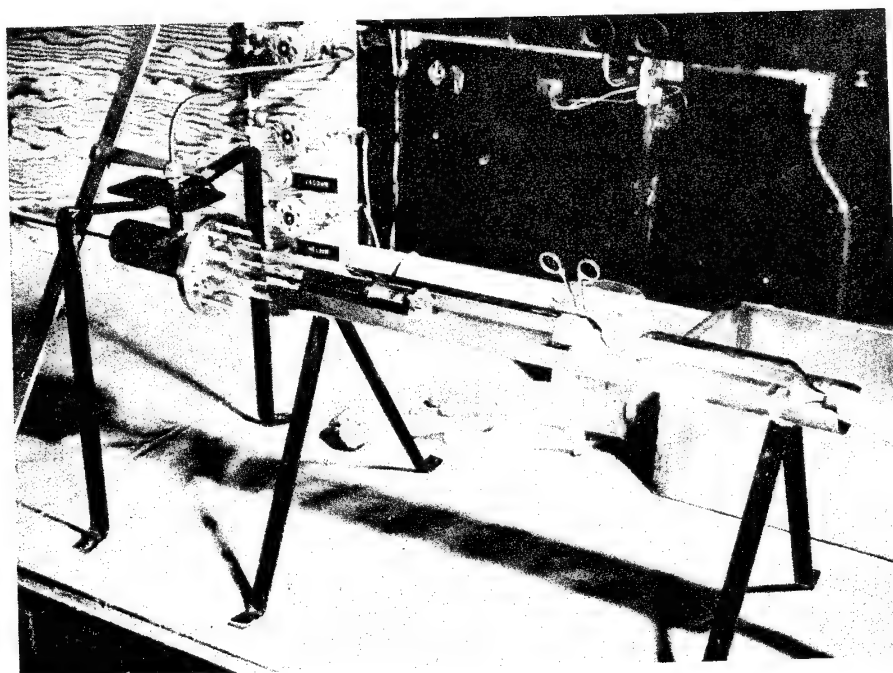
Figure 14. Assembly entering the pyrex container.

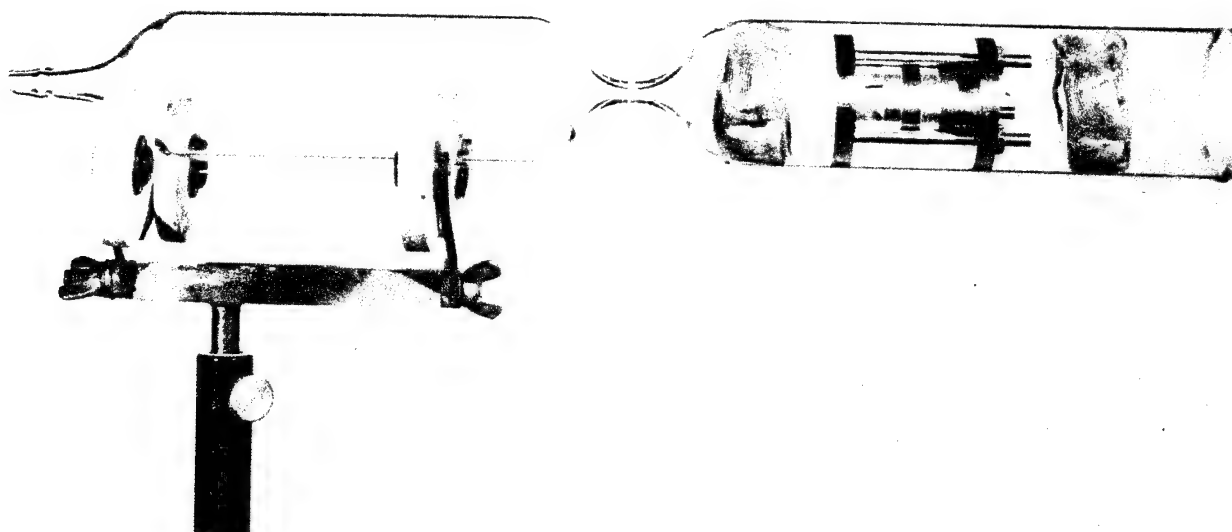
Figure 15. Assembly prepared for sealing off the container.

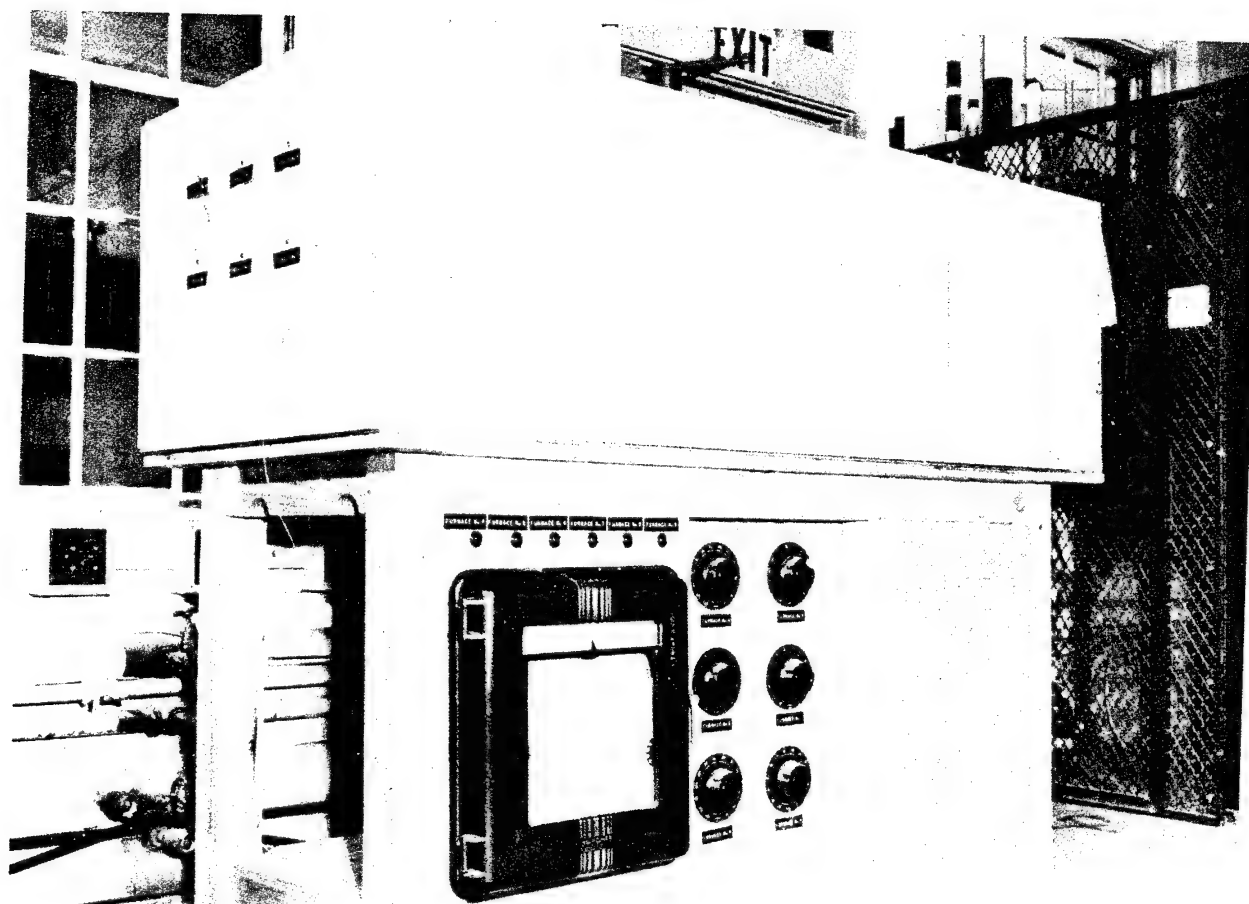
Figure 16. Constant temperature tube furnaces.

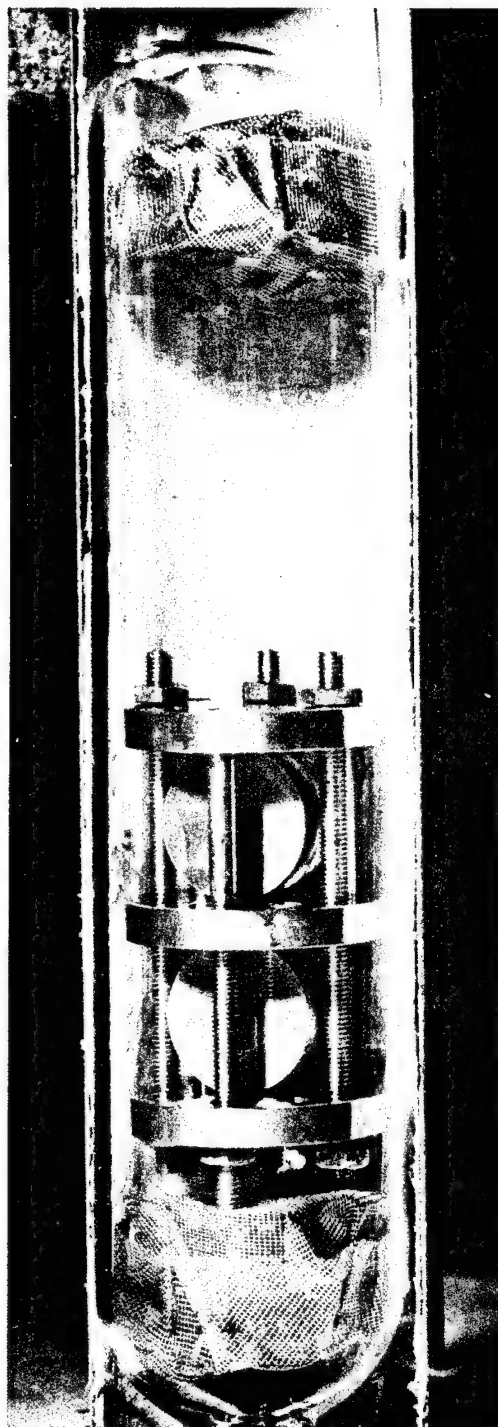
Figure 17. Assembly #7 - low interface pressure.

In the case of Assembly #7, a uranium disk was placed on top of an aluminum disk and vice versa. A photograph of this assembly is shown in Figure 17. When Assemblies #9 and #10 were made, the nickel baskets with uranium turnings, were left out of the container, since air and helium atmospheres, respectively, were used for this test. The aluminum disks used for Assembly #12 were anodized according to the procedure used for the Brookhaven finned aluminum tubing.

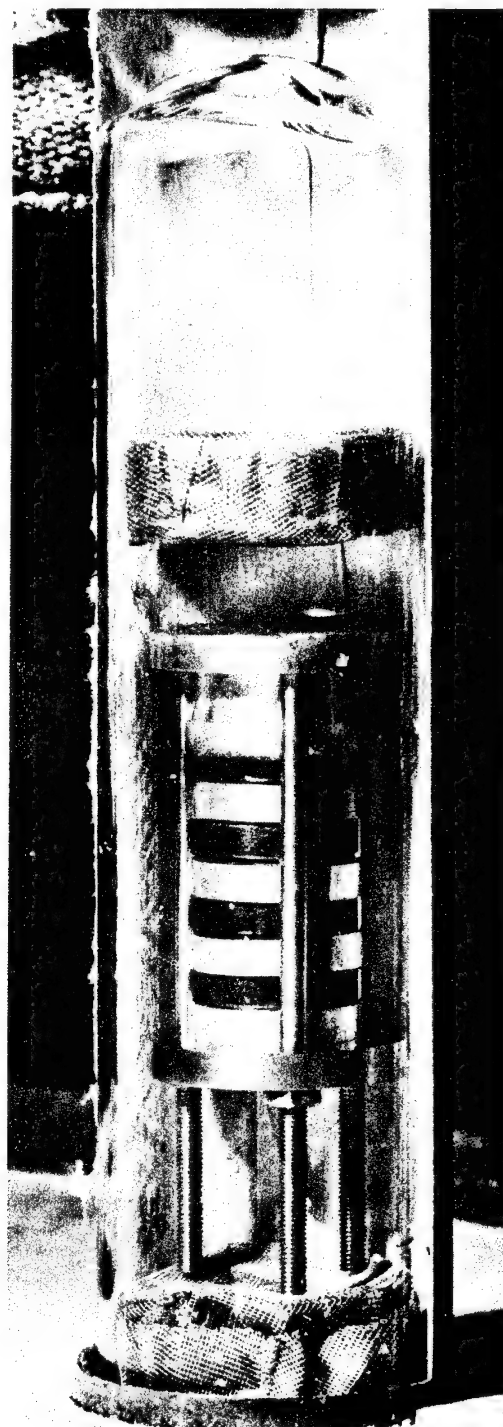
Figure 18. An assembly with advanced alloy formation (#2).
